Manhole Inspection Summary

Manhole # S19AA1011MH

Insp Date: **3/13/07 2:40 PM**

Location Address: **2262 DRUID PARK DR**

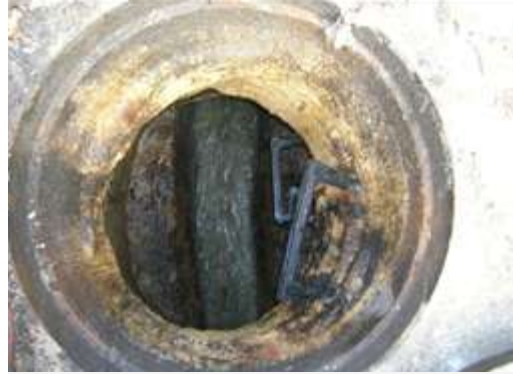
Top View

Bench debris.

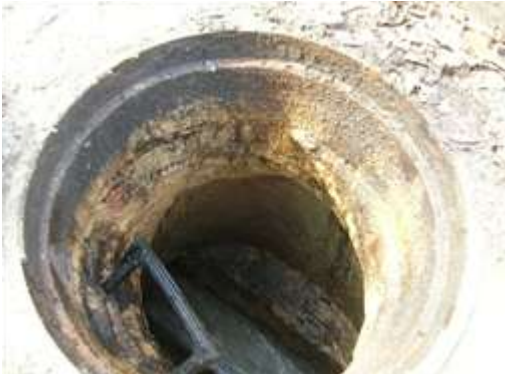
Defect

Frame Offset: **0** (in.) Condition: ☐ Sound ☐ Cracked ☒ **Leaks**

Infiltration: ☐ None ☒ **Joint** ☐ Cracks ☐ Mortar ☐ Roots ☐ Wall

Frame leaks. Adjustment infiltration.

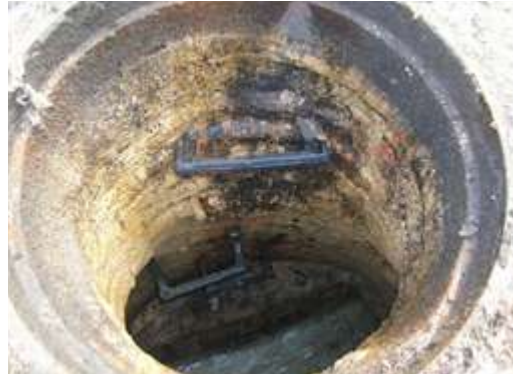
Defect

Frame leaks. Adjustment infiltration

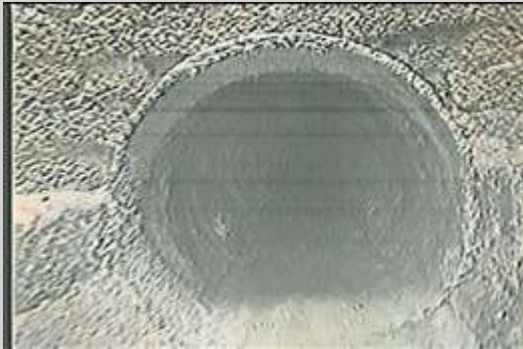
15 in. Circular Gravity Sewer Pipe Out @ 12 O'Clock

Pipe Material: **Unknown** ☒ Pipe Lined

Invert Depth: **7.30** (ft.) Flow Characteristics: **Fast**

Infiltration: **None** Pipe Seal Cond: **Unknown**

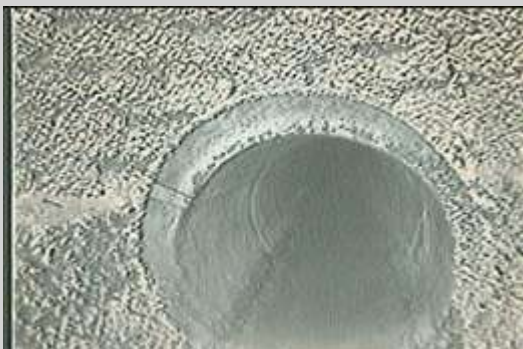
18 in. Circular Gravity Sewer Pipe In @ 6 O'Clock

Pipe Material: **Unknown** ☒ Pipe Lined

Invert Depth: **7.30** (ft.) Flow Characteristics: **Fast**

Infiltration: **None** Pipe Seal Cond: **Unknown**
